SEAWATER LUBRICATED PROPELLER SHAFT BEARINGS - AVOIDING PROBLEMS

THE ISSUES

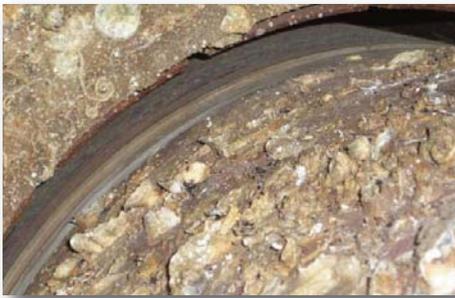
Marine growth on the shaft liner will prematurely wear a bearing. These deposits, including calcium carbonate deposits will disrupt the hydrodynamic film and create an abrasive environment for the bearing.

Typical marine growth on shaft

- Turn the shaft 2.5 revolutions every 2-3 days while alongside or at anchor to help reduce marine growth build up.
- Fresh water pumped into stern tube when the ship is idle will inhibit marine growth in the strut and stern tube bearings. A flow of 1x the water volume in the stern tube per day should be sufficient but can be adjusted for local environmental conditions.
- Active cathodic protection systems which are not operated properly and maintained can lead to material plating out on the shaft liner, leading to abrasive wear

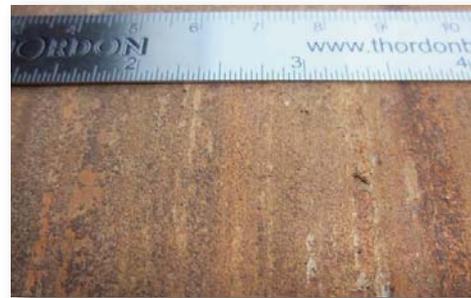
Material plating on the shaft liner

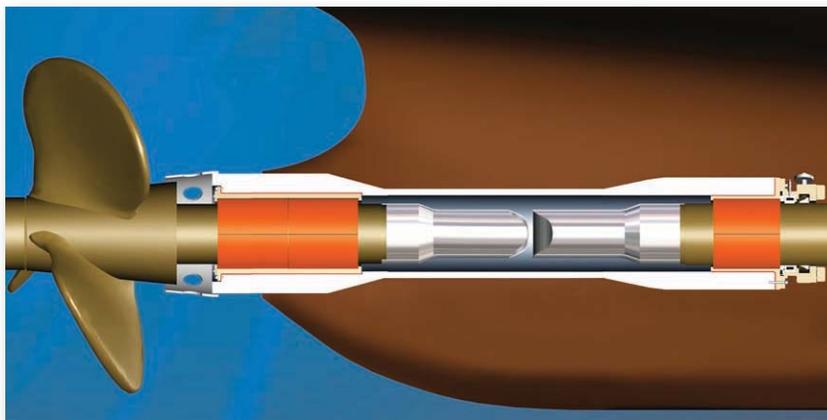
COMPAC Seawater Lubricated Stern Tube Bearing System
