FINNISH NAVY FINISHED WITH RUBBER BEARINGS

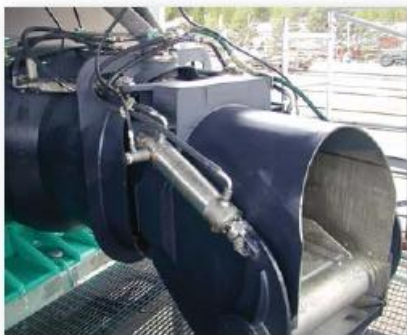
Water jet nozzle equipped with water lubricated Thordon GM2401 line bearings

Water jets are generally used in most Finnish Navy light and fast patrol vessels bigger than open outboard motor boats. The first of their fast attack missile boats to use them were the *Rauma* class vessels. In the propulsion shaft line is a water lubricated line bearing, located inside the stator of the water jet's jet pipe.
